December 21, 1992
Project No. 40104.50

Re: Vadose Zone Monitoring in the Solar Ponds Operable Unit 4 (OU4) Area

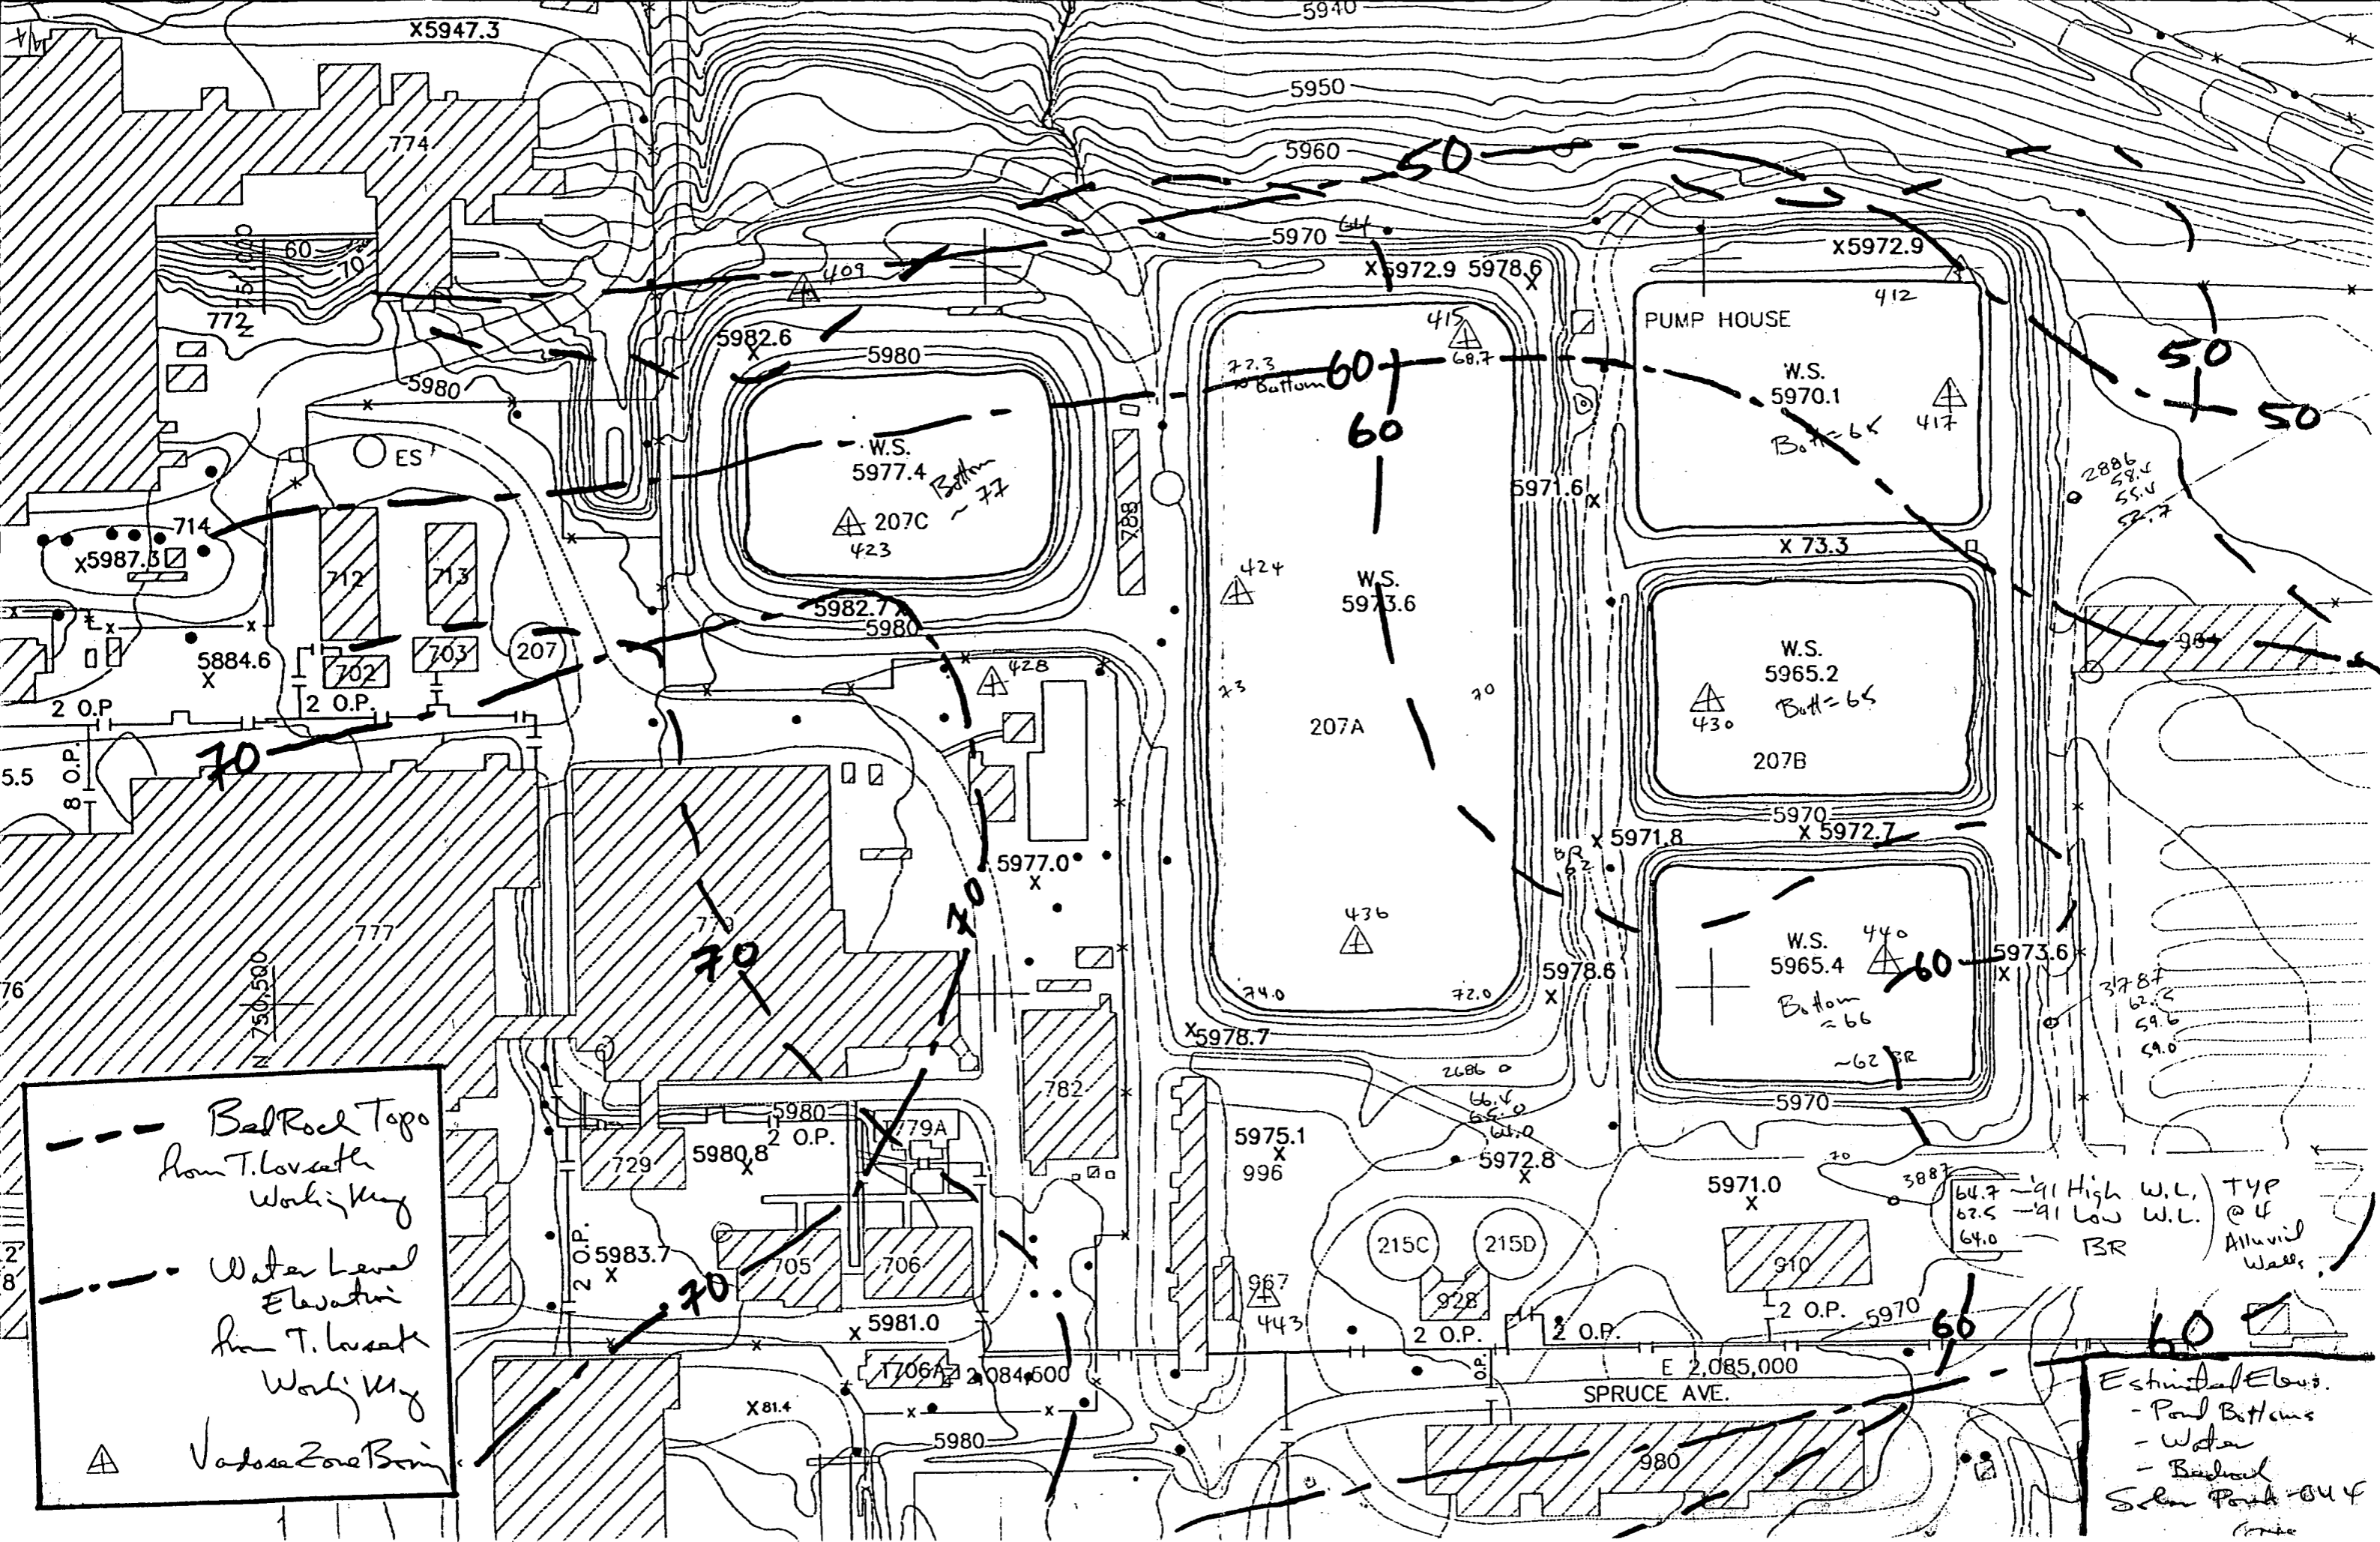
--- Bad Rock Topo
from T. Lovsath
Working Map

--- Water Level
Elevation
from T. Lovsath
Working Map

The attached table presents the estimated depths to water and to bedrock at the proposed vadose zone boring locations in the vicinity of the solar ponds. The estimated depth to water is based on interpolations from Tim Lovseth's working water table map for the Rocky Flats Alluvium. Water levels under or near the ponds may be shallower if the ponds are leaking or have leaked. The attached rough figure shows locations of vadose borings and estimated elevations for pond bottoms, water table, and bedrock in the vicinity of the solar ponds.

Bedrock elevations were estimated primarily from a working bedrock topographic map prepared by Tim Lovseth of EG&G Rocky Flats (EG&G). As shown by the range in estimated bedrock elevations for Locations 40993 and 41593, there is significant uncertainty in the bedrock elevation north of the ponds.
